ASCOM

- LBS 50
- Serial No 93003
- Year 1993
- Eastbourn Marina

June 2020 LOLER / PUWER Inspection Report – Jib Crane ontop of hoist not tested as winch drum switch faulty

December 2019 LOLER / PUWER Inspection Report

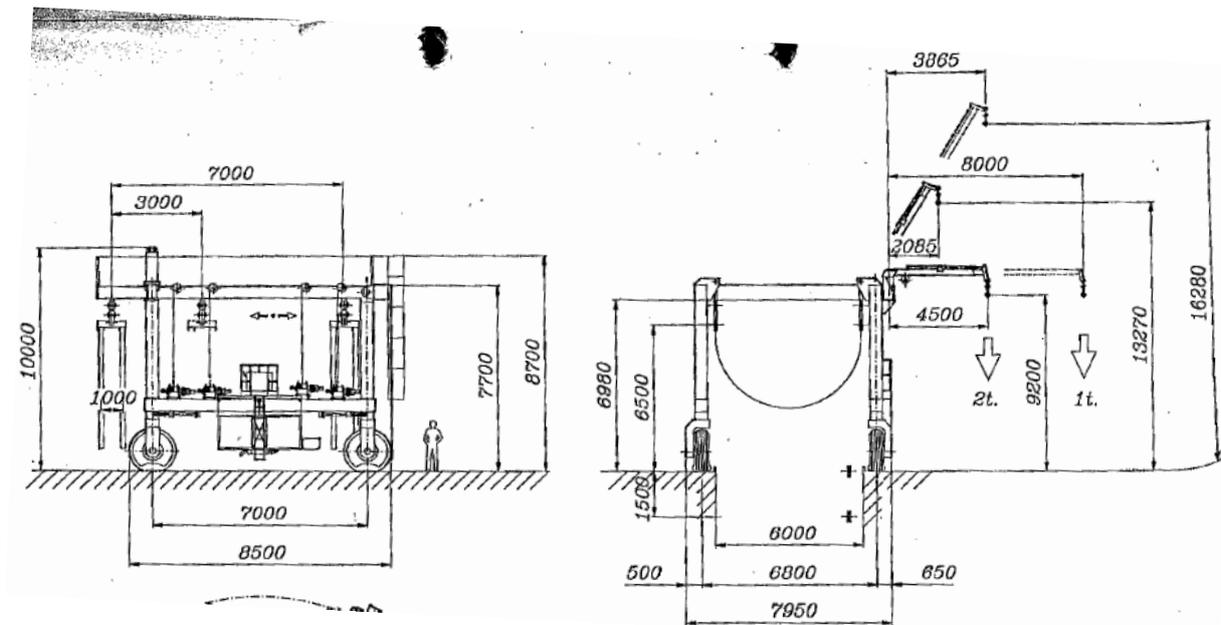
SC1 09-Dec-2019 16-Jun-2020 16-Dec-2020	Straddle Carrier 93003 Ascom Not marked Boatyard	50 tonne	A None B Several sections of steelwork have areas of corrosion. All wheels steelwork has corroded. Lifting block 2 has one securing screw sheared off from its rope pulley guard. C It is strongly recommended the steelwork with corrosion should have a suitable NDT (none destructive testing) in order to assure that all steelwork is structurally sound. It is recommended the load ropes should be cleaned and suitable lubricated.
--	--	----------	--

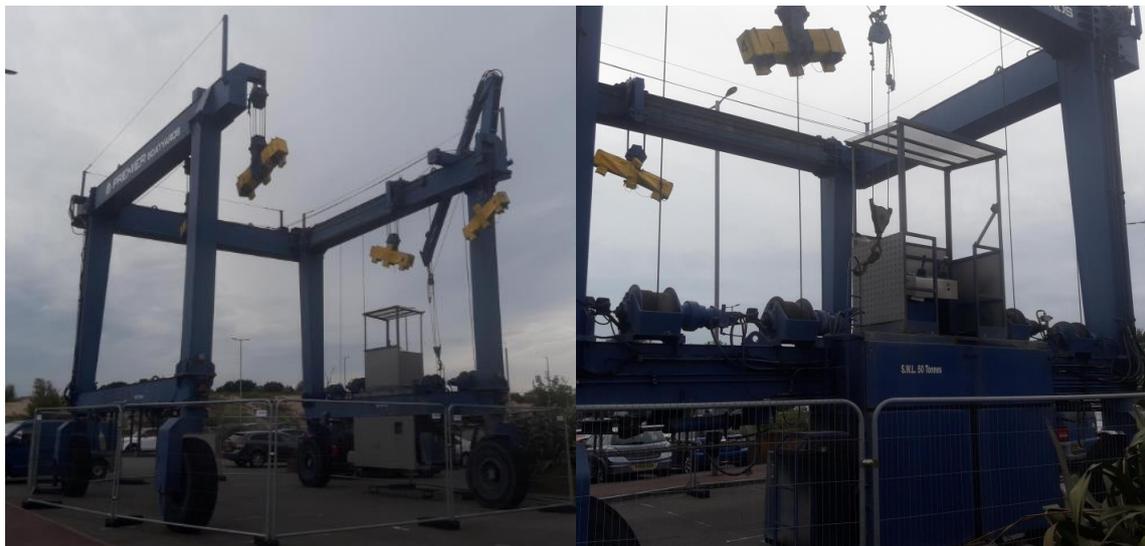
<p>TC1 17-Jun-2019 09-Dec-2019 09-Jun-2020</p>	<p>Crane 128 93 Heila 1993 Attached to the Straddle Carrier</p>	<p>1750kg at minimum load radius</p>	<p>A None B Surface corrosion is forming on several areas of steelwork. The upper hook limit is inoperative. The 'winch in' button will only operate if it is pressed with the 'boom in' button top begin with. C None</p>
<p>SC1 17-Jun-2019 09-Dec-2019 09-Jun-2020</p>	<p>Straddle Carrier 93003 Ascom Boatyard</p>	<p>50 tonne</p>	<p>A None B Several sections of steelwork have areas of corrosion. The wheel on the same corner as hoist block 2 is corroded. C It is recommended the steelwork with corrosion should have a suitable NDT (none destructive testing) in order to assure that all steelwork is structurally sound. It is recommended the load ropes should be cleaned and suitable lubricated.</p>
