ASCOM

- LBS 50
- Serial No 93003
- Year 1993
- Eastbourn Marina

June 2020 LOLER / PUWER Inspection Report – Jib Crane ontop of hoist not tested as winch drum switch faulty

December 2019 LOLER / PUWER Inspection Report

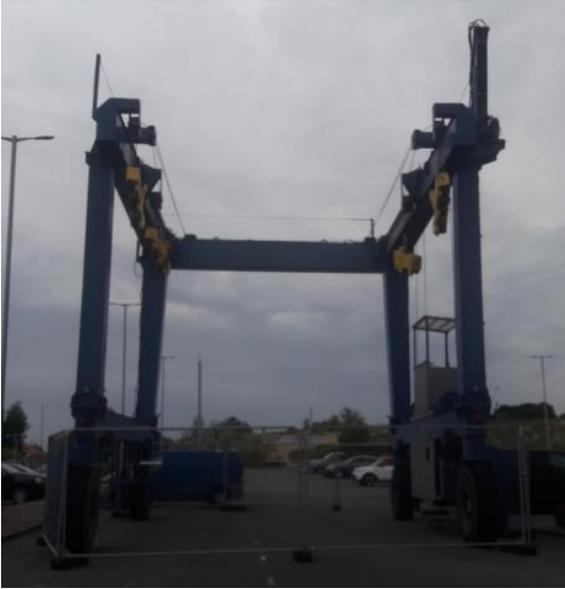
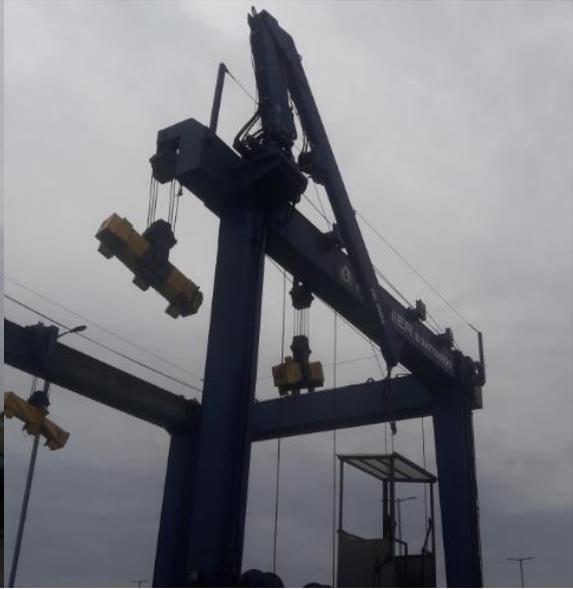
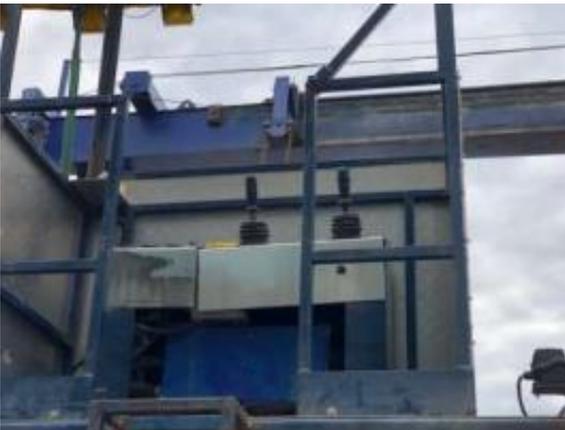
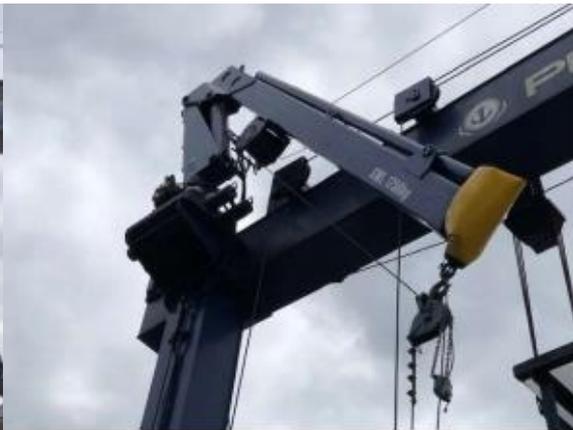
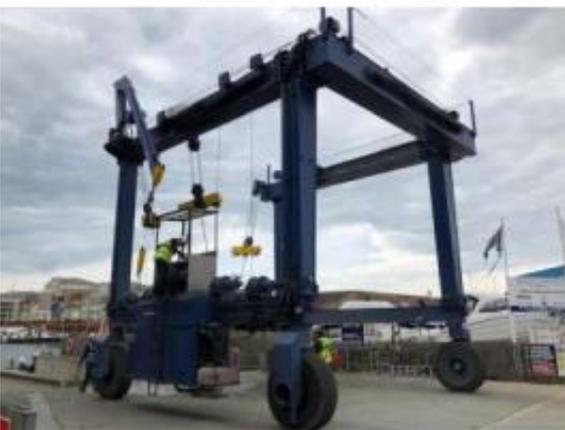
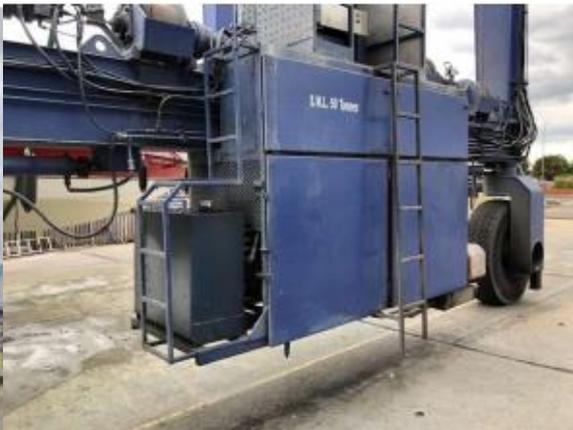
SC1 09-Dec-2019 16-Jun-2020 16-Dec-2020	Straddle Carrier 93003 Ascom Not marked Boatyard	50 tonne	A None B Several sections of steelwork have areas of corrosion. All wheels steelwork has corroded. Lifting block 2 has one securing screw sheared off from its rope pulley guard. C It is strongly recommended the steelwork with corrosion should have a suitable NDT (none destructive testing) in order to assure that all steelwork is structurally sound. It is recommended the load ropes should be cleaned and suitable lubricated.
--	--	----------	--

<p>TC1 17-Jun-2019 09-Dec-2019 09-Jun-2020</p>	<p>Crane 128 93 Heila 1993 Attached to the Straddle Carrier</p>	<p>1750kg at minimum load radius</p>	<p>A None B Surface corrosion is forming on several areas of steelwork. The upper hook limit is inoperative. The 'winch in' button will only operate if it is pressed with the 'boom in' button top begin with. C None</p>
<p>SC1 17-Jun-2019 09-Dec-2019 09-Jun-2020</p>	<p>Straddle Carrier 93003 Ascom Boatyard</p>	<p>50 tonne</p>	<p>A None B Several sections of steelwork have areas of corrosion. The wheel on the same corner as hoist block 2 is corroded. C It is recommended the steelwork with corrosion should have a suitable NDT (none destructive testing) in order to assure that all steelwork is structurally sound. It is recommended the load ropes should be cleaned and suitable lubricated.</p>
